Building Inspection Report

10 Christine Rd, Marlborough, CT, 06447

Inspection Date:
3/30/04

Report Number:
330041

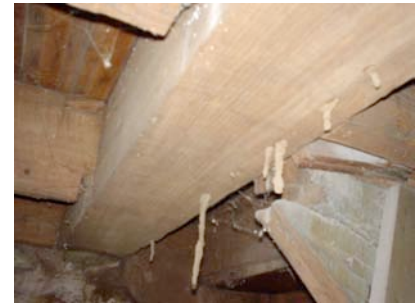
- **Major Concern, Repair:** Evidence of termite activity was observed (See Photo Of Termite Shelter Tubes) and there is risk of additional hidden damage. If the property has not already been treated, a licensed pest control specialist should be consulted. Termites can do a substantial amount of damage to the wood structural components of a home.
- **Repair:** A beam is cracked. Further cracking or movement risks serious structural movement and damage. Re-supporting this beam is recommended.

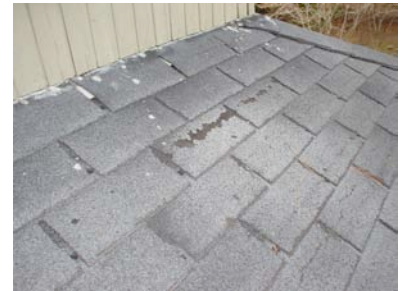
- **Major Concern, Repair:** The roofing exhibited excessive granule loss (See Photo) and is at the end of its useful life. Allow for replacement of the roof.
- **Repair:** The downspout(s) should discharge water at least five (5) feet from the house. Storm water should be encouraged to flow away from the building at the point of discharge.
